計畫名稱：太陽光電模組加速老化因子之研究

期末報告

執行單位：財團法人成大研究發展基金會

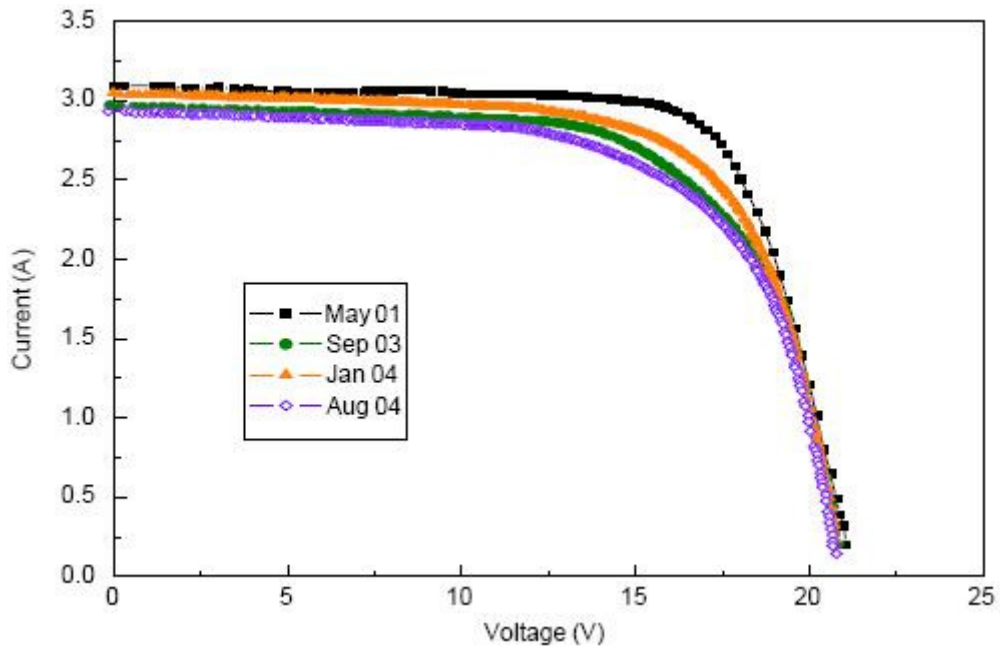
圖23 模組不同時間下的電流-電壓關係圖[8]

圖 23 為實驗模組的電流-電壓特性曲線圖，圖中分別為不同時間下所量測出的數據，可發現隨著時間增加，模組之輸出效能逐漸降低。其中短路電流之斜率幾乎維持於一定值，並無顯著變化，表示太陽能電池的並聯電阻在戶外曝曬期間並沒有顯著下降；相對的，開路電壓的斜率卻隨著時間的不同而有所變化，表示太陽能電池之間的串聯電阻逐漸增加。實際電阻值量測的結果顯示，在 2001 年時，串聯電阻為 0.4 歐姆，直到 2004 年時，增加為 0.9 歐姆，由圖 24 中可以由觀察模組匯流排腐蝕現象判斷主要造成串聯電阻上升的原因為匯流排接點間的腐蝕老化所致，如圖 24 所示。

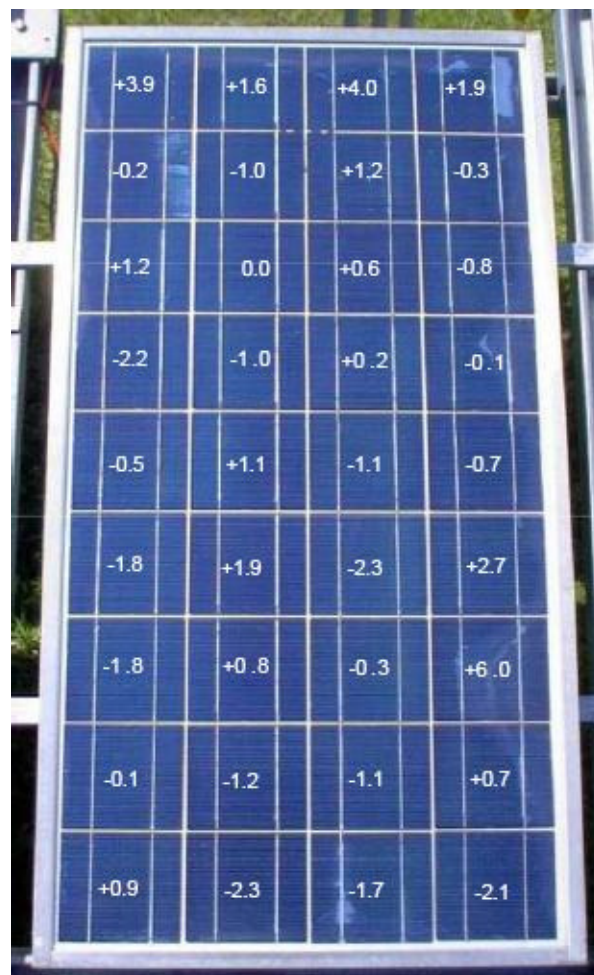
圖25 模組最後曝曬時的溫度與總曝曬運作溫度平均值的差值[8]

進一步分析可知模組中各層介面剝落和水氣的侵入都會造成太陽能電池特性不匹配(mismatch)的現象，主要原因為較少的陽光能夠到達發生剝落和水氣侵入處，當有不匹配的情況產生時，會造成該處太陽能電池運作溫度的上升，為了解此現象，該實驗亦量測該太陽能模組表面溫度，如圖 25 所示。

由圖 25 可發現，對照圖 19 中被水氣侵入的剝落區域，這些區域的溫度都有顯著提升，該數據是選取在戶外曝曬最後時段的溫度

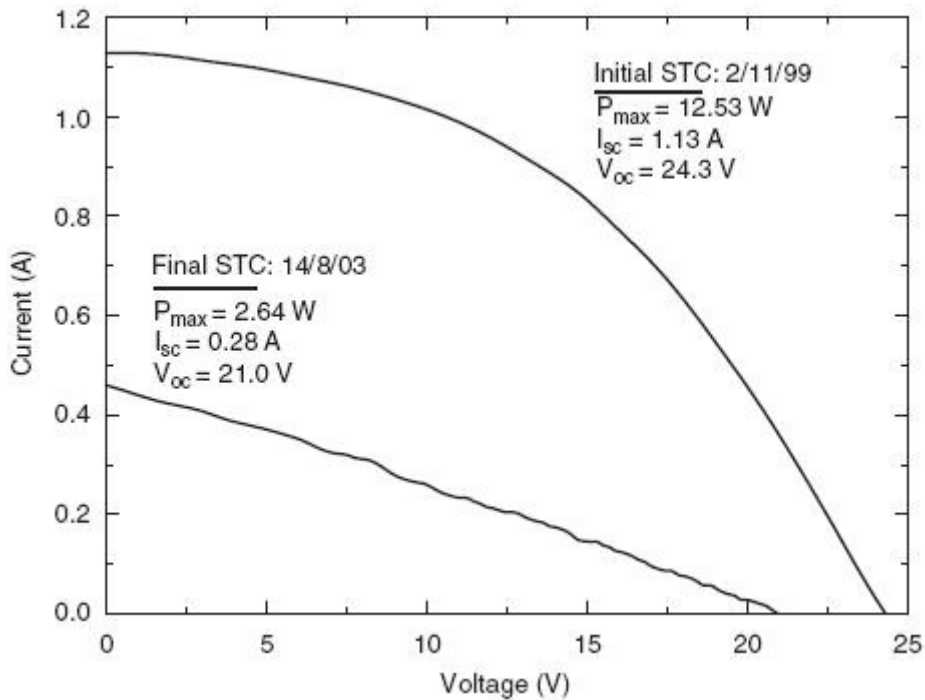
圖27 模組之初始與最終電流-電壓關係曲線圖[9]

由圖 27 中亦可觀察到短路電流之斜率有增加之情形，可推斷為電池間之並聯電阻值減少，且可觀察到開路電壓之斜率為減少的情況，即太陽能電池間串聯電阻值之增加，此電阻值之增加主因為在模組中鋁化合物的生成。

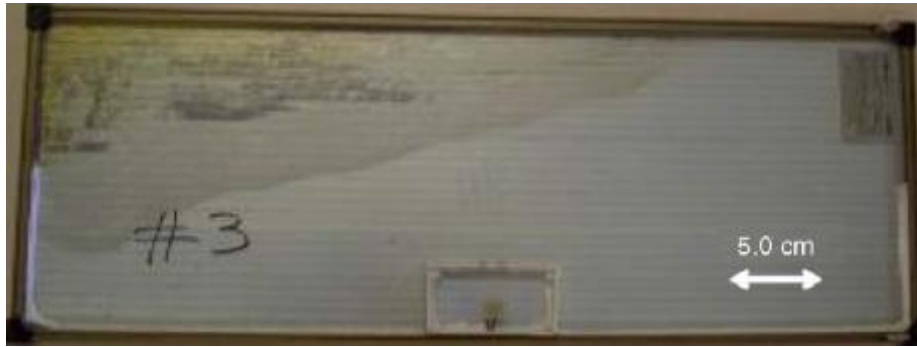
圖28 模組背面之介面剝落與水氣侵入的情形[9]

將金屬外框拆除後可以見到太陽能電池模組老化的情形，如圖 28 所示，可以清楚看到水氣的侵入以及模組本體上的劣化現象，因為太陽能電池、EVA 和玻璃之間的剝落所造成的間隙，於是造成水氣的侵入和腐蝕。

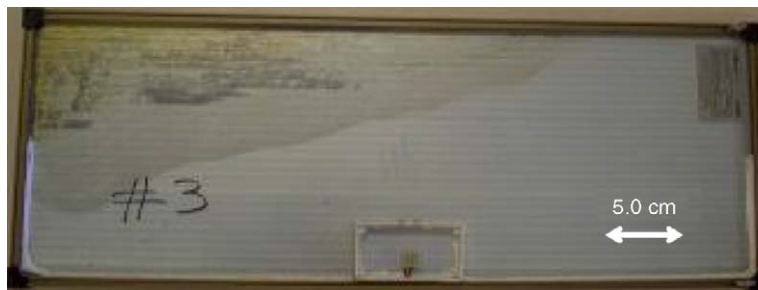
Fig. 3. Photograph of rear of module showing delamination and moisture ingress.

As shown in Fig. 3, the main moisture ingress was from the top left region of the module, with the moisture infiltration being between the EVA and silicon layers, where the aluminium back contact is situated. Activated by the electric field generated by the cells and the water

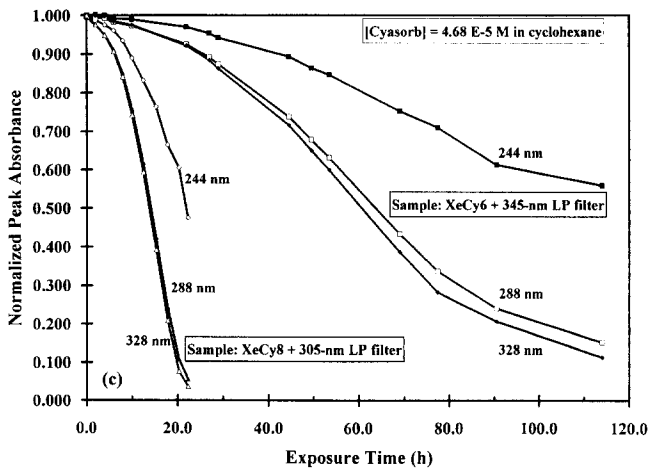
Fig. 4. Photodecomposition of Cyasorb in cyclohexane solutions exposed to the concentrated 1-kW Xe light filtered by an aqueous  $\text{CuSO}_4$  solution (i.e., C-Xe in Fig. 1b) with (a) a 305-nm long pass (LP) filter and an OD = 0.5 ND filter, or (b) a 345-nm LP filter, at a black panel temperature (BPT) of  $55^\circ \pm 2^\circ\text{C}$ . (c) The decomposition of Cyasorb in (a) and (b) are plotted for the three absorption peaks at 244 nm, 288 nm, and 328 nm.

The photodecomposition rate of Cyasorb in cyclohexane solutions was quantitatively studied by exposure to different intensities of the 1-kW C-Xe light. The light intensity level was attenuated by using neutral density filters of various optical density. The results, and the derived curve-fit parameters, are shown in Fig. 6, indicating the photodecomposition rate of Cyasorb in cyclohexane is exponentially proportional to the light intensity.

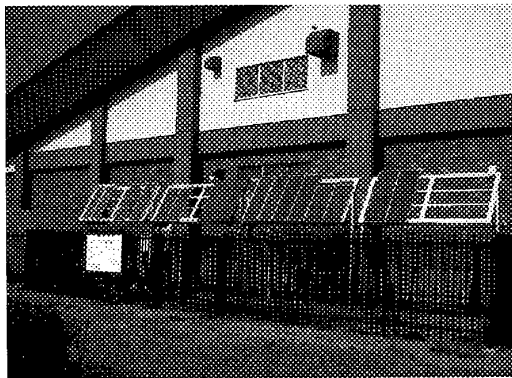
Fig.1 The field exposure test site

26 crystalline-Si PV modules supplied by 3 manufactures were installed on 4 sites in Japan during 1991-1993 and in 1997. The photograph of one of the sites is shown in Fig.1. The modules were connected with the lead acid battery and were periodically carried from the sites to the laboratory for IV characteristic measurements by a solar simulator to find the detailed change. And in order to understand the conditions of a large number of modules, in addition to the above, about 100 modules (4 manufactures) installed in 1991 were removed from the large-scale PV system to the laboratory and measured IV characteristic by a solar simulator. The IV characteristic measurements were performed at standard test condition (AM.1.5, 1kW/m<sup>2</sup>, 25°C).
